Physical Accessibility to Programs and Services

2025MS-1 | May 2025

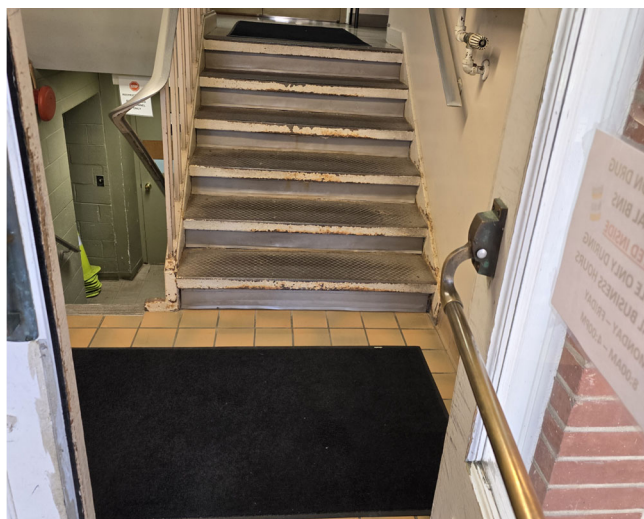
FIGURE 2

In a few instances, buildings were not accessible because of stairs, or the alternative entrance did not provide access to all services available to other residents. In one instance, the only public entrance at a City's police station did not provide wheelchair access to the main floor (Figure 2).

Approach and Entrance Potential Improvement Example^a

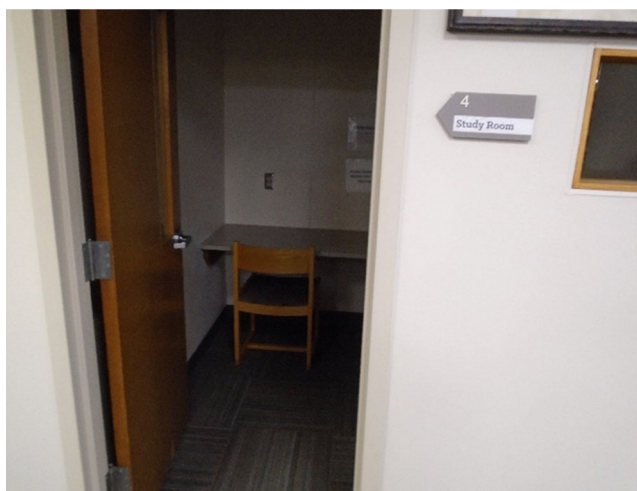
FIGURE 3

In one instance, the interior doors to the study rooms at a public library had inadequate door clearances, limiting access (Figure 3).

Access to Services Potential Improvement Example^a

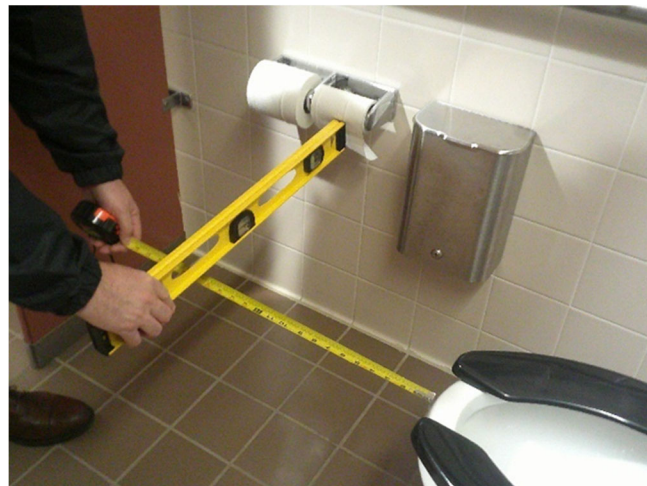
FIGURE 4

In several instances, soap dispensers, hand dryers and other fixtures were mounted too high or otherwise out of reach by individuals in wheelchairs (Figure 4).

Restroom Potential Improvement Example^a

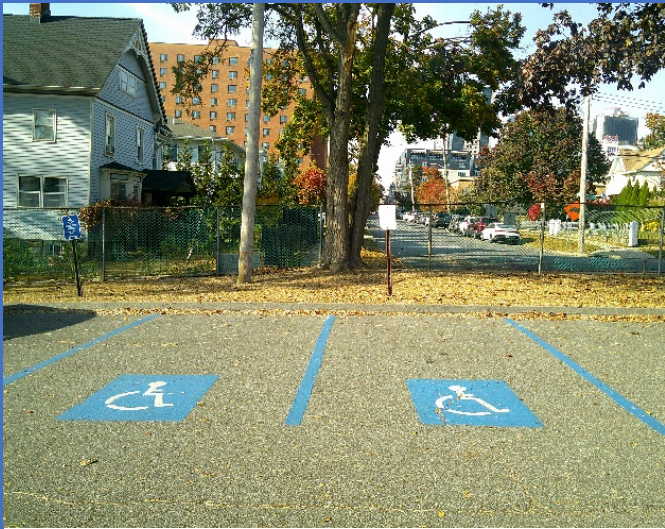
Parking spaces without signs or access aisles at one City's senior center.

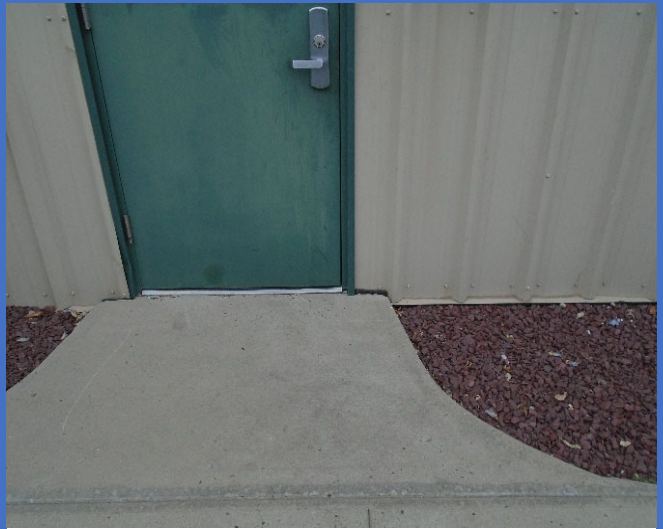
Not enough clearance on the latch side of the door to accommodate a wheelchair at a Town's recycling center.

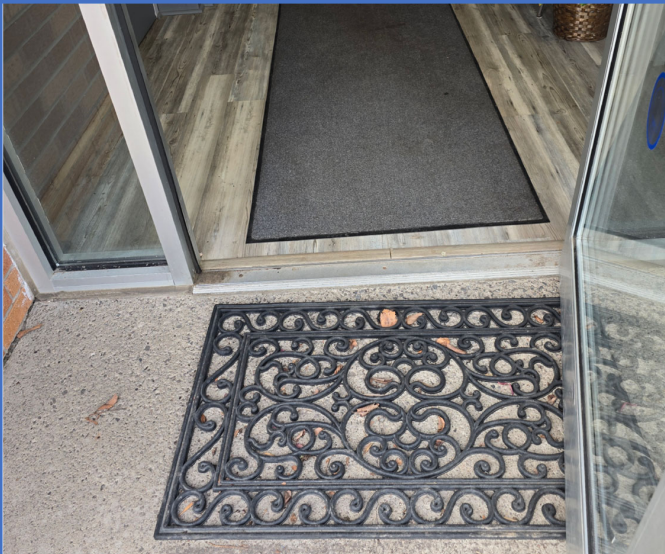
The mats at the entrance to a Town's highway department were not secured to prevent tripping hazards.

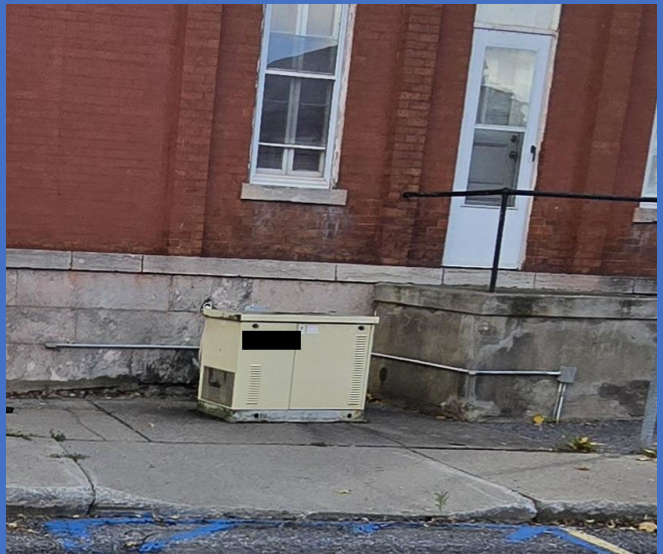
The level landing at the top of a curb ramp along the accessible route at a City's police facility was obstructed by a generator.

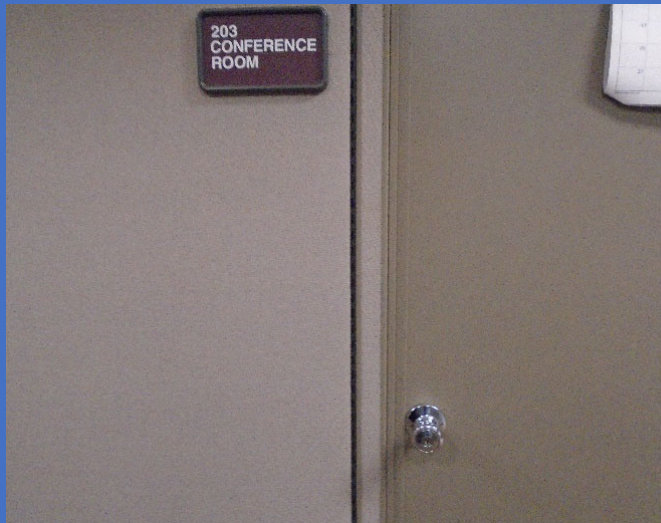
Conference room door at a City Hall has a doorknob, and not an accessible handle such as a latch or lever that can be operated without grasping or twisting.

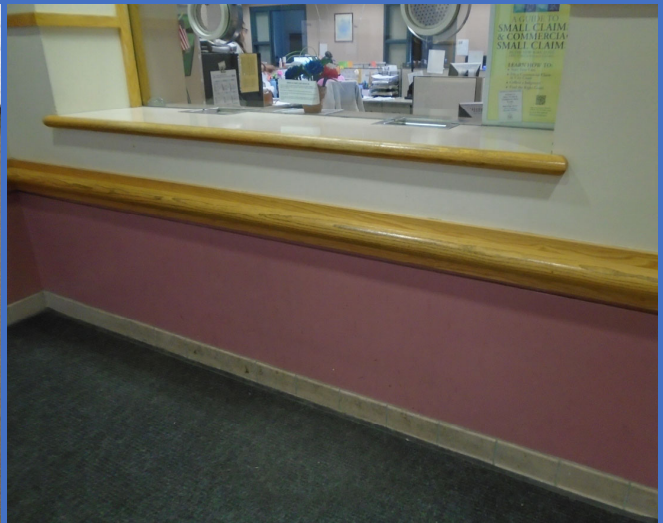
Service counter at a Town's public safety center without an accessible portion that is no higher than 36 inches.

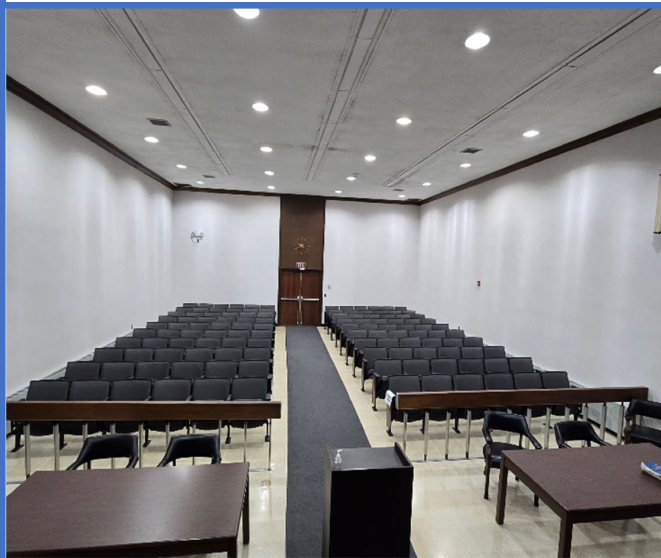
Permanent seating in the public viewing area of a Town's courtroom does not include wheelchair accessible spaces.

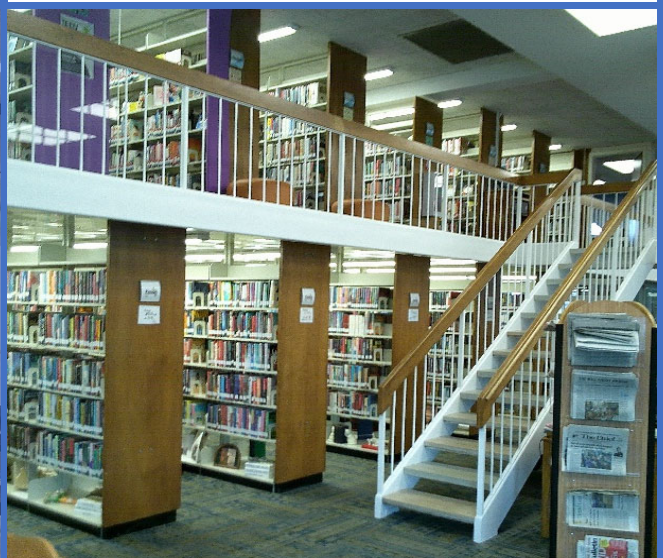
The upper-level of a public library is only accessible by a stairway.

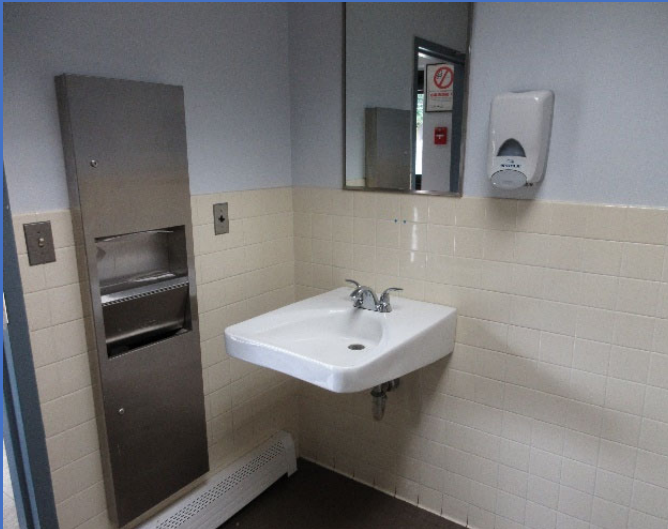
The public restroom sink, mirror and soap dispenser in a Town's police station are too high.

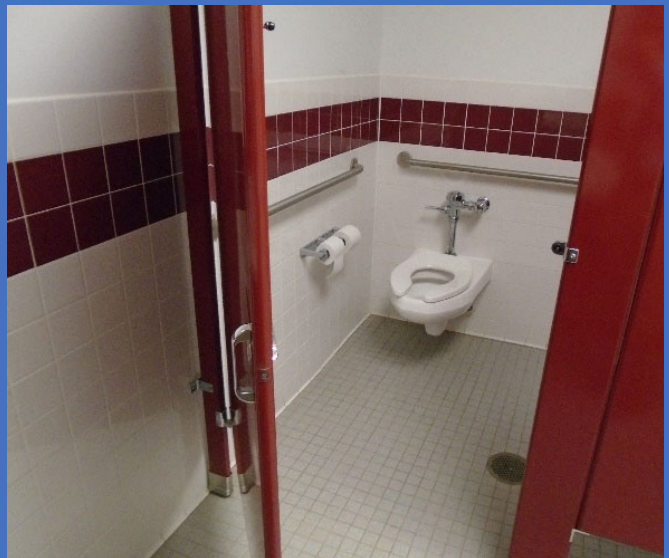
Doors to accessible stalls in restrooms at a Town Hall do not have automatic door closers making wheelchair use difficult.
