# Metropolitan Transportation Authority – New York City Transit

## Risk Assessment and Implementation of Measures to Address Extreme Weather Conditions

Report 2021-S-27 | September 2023

OFFICE OF THE NEW YORK STATE COMPTROLLER  
Thomas P. DiNapoli, State Comptroller

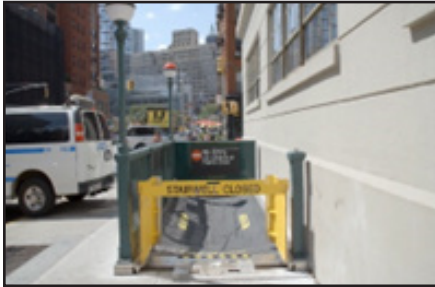
**Figure 1** – A flex-gate is a permanently installed containment box within a staircase and a deployable fabric cover, which can be locked in place when a storm event occurs. Franklin Street Station #1.

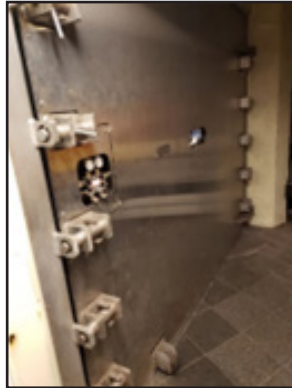
**Figure 2** – Marine flood doors are permanently installed watertight doors at the bottom of a staircase within a subway station. Whitehall and Stone Street 12/13/2021.

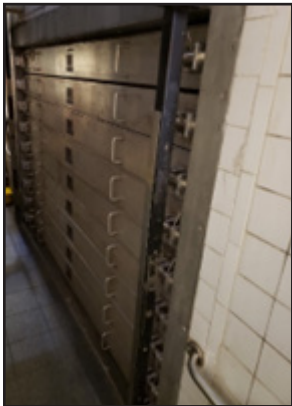
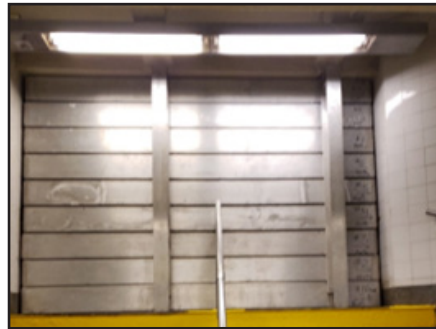
**Figure 3** – Stop logs consist of a deployable set of watertight vertical metal logs that can be installed around station entrances to protect against water intrusion, especially where it is not feasible to install swinging or sliding doors. Whitehall Street Station 12/13/2021.

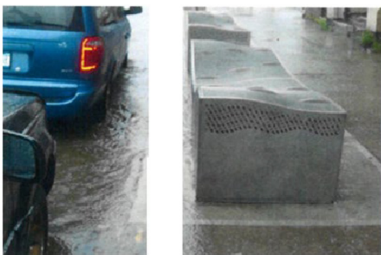
Then, in 2007, following a severe rainstorm, NYCT partnered with various NYC agencies to conduct a surface flood study, analyzing the historic effects of rainfall and resultant flooding throughout the subway system. In 2008, aided with this information and other input from Columbia University's Center for Climate Change Research, NYCT began implementing asset-specific protection measures (e.g., raising ventilation gratings above street level) in the subway system's most flood-prone locations.

**Fig. 1:** Raised Ventilator / Streetscape Preventing Water Ingress during Storm Flooding
